8 IN THE UNITED STATES DISTRICT COURT  
9 SOUTHERN DISTRICT OF CALIFORNIA

Case No.: 08 CV 0352 BEN  
(CAB)

**DECLARATION OF NARADIN  
MOHAMED IN SUPPORT OF  
PLAINTIFF'S OPPOSITION TO  
MOTION TO DISMISS**

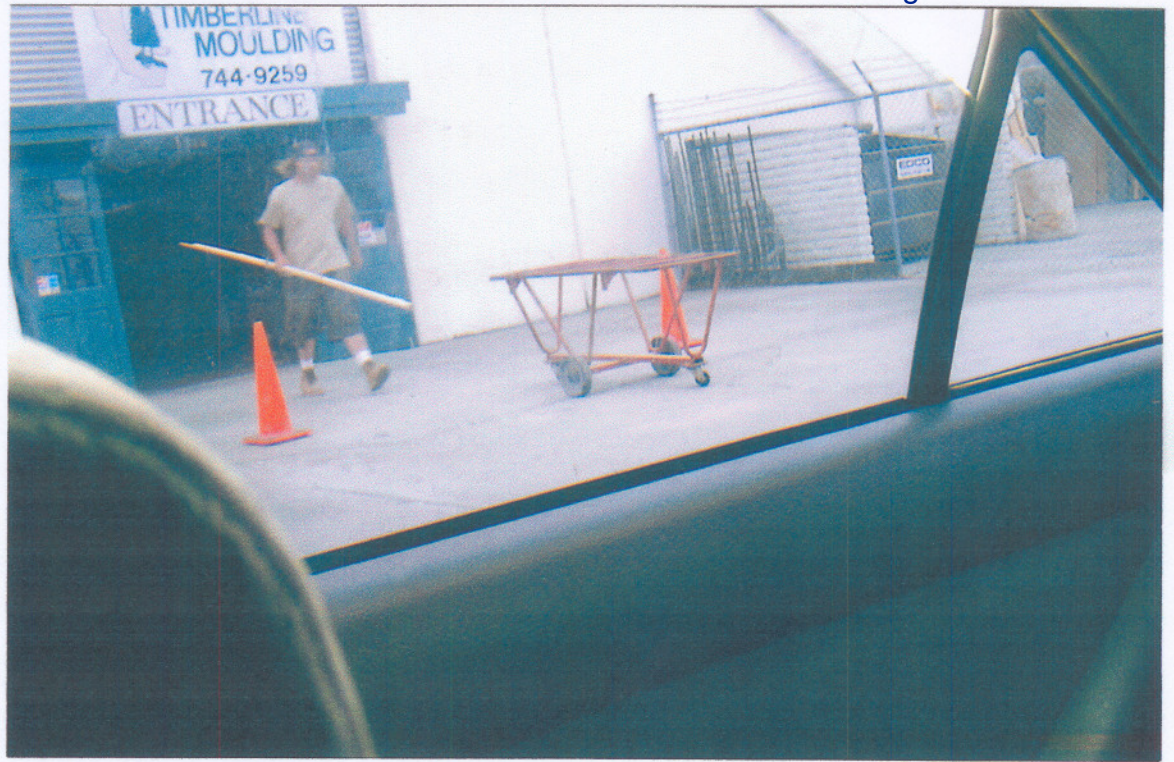
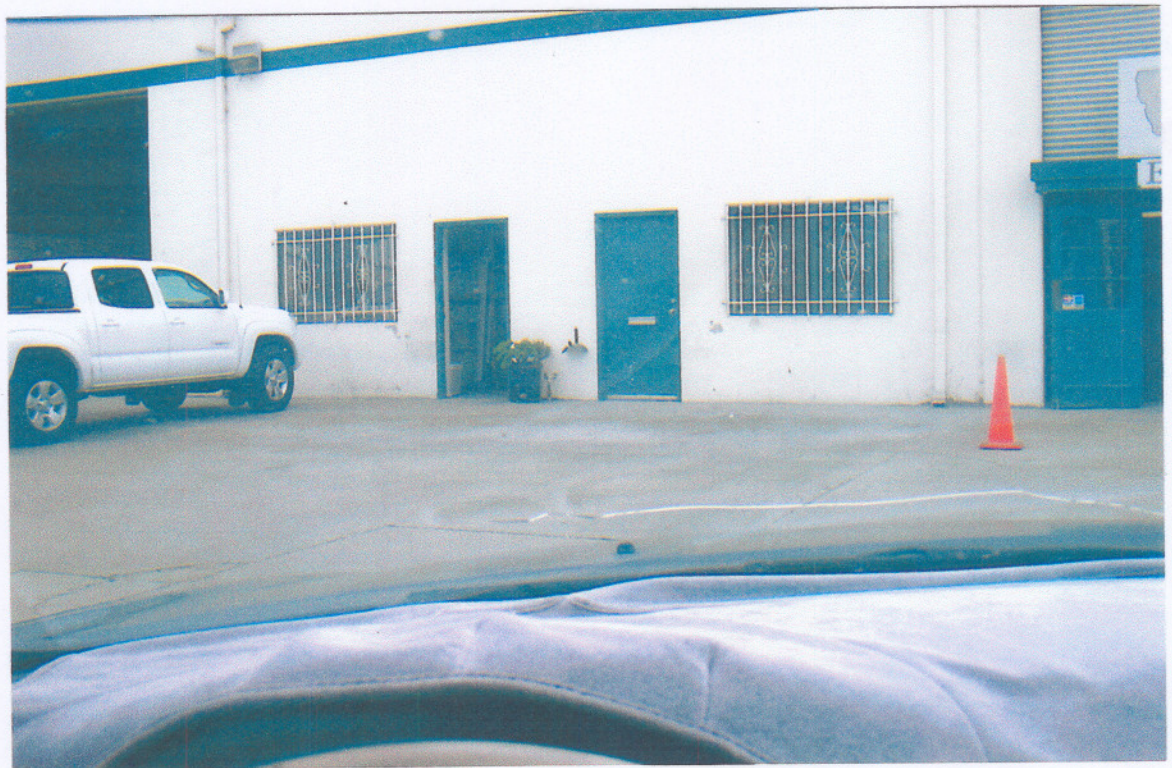
EXHIBIT "1"

7       4. At the time of my visit to Timberline Moulding, on  
8 November 30, 2007, there was no accessible parking space at the  
9 property. The absence of an accessible parking space is depicted  
10 in the photos in Exhibit "1". I reviewed Exhibits "H" and "I" to  
11 Defendants' Motion to Dismiss, as well the Declaration of Susan  
12 Wait. Neither of the delineated parking spaces depicted in those  
13 photos existed at the property when I visited on November 30,  
14 2007. Further, Exhibits "H" and "I" do not depict any sign which  
15 warns that vehicles parked in the accessible space without  
16 placards or license plates issued for people with disabilities  
17 may be towed at the owner's expense. None of Defendants'  
18 photographs depict the entrance to the parking lot.

19       5. Exhibit "4" depicts the sole entrance to the parking  
20 lot at the property as it existed during my visit of November 30,  
21 2007. As shown in Exhibits "1" and "4", there are no signs at  
22 the entrance to the parking lot or in the parking area adjacent  
23 to the front entrance which warns that vehicles parked in the  
24 accessible space without placards or license plates issued for  
25 people with disabilities may be towed at the owner's expense.

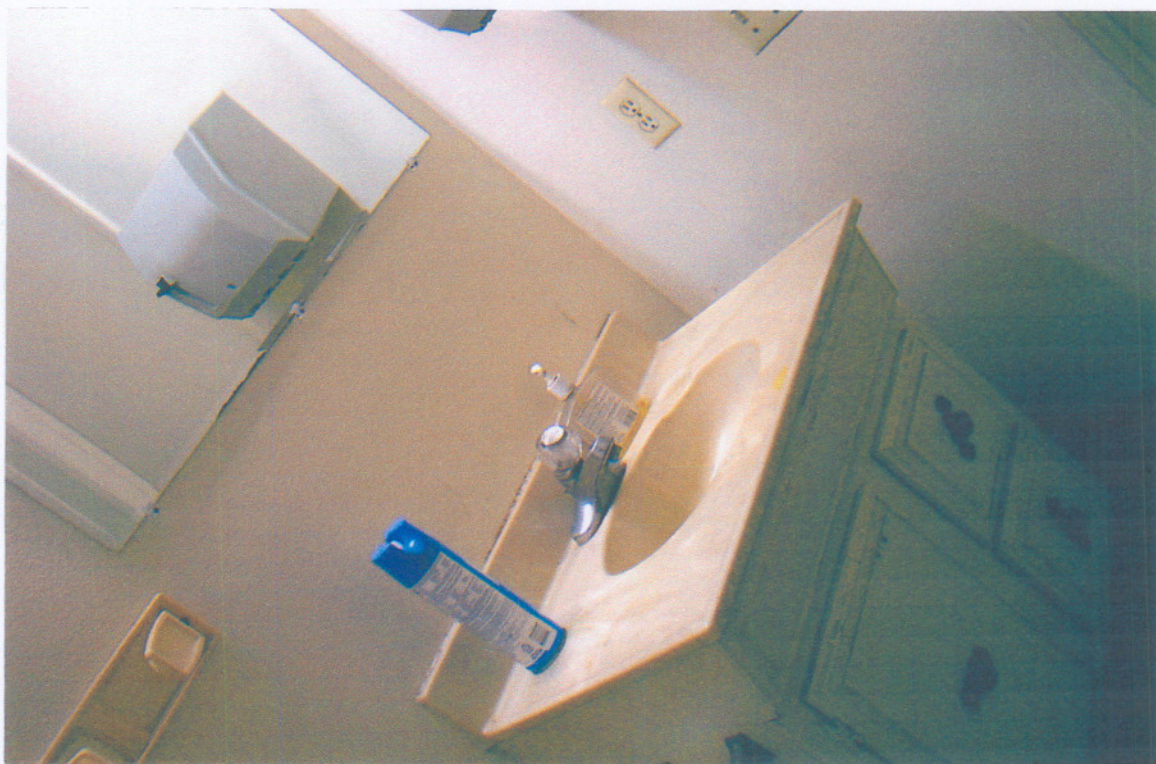
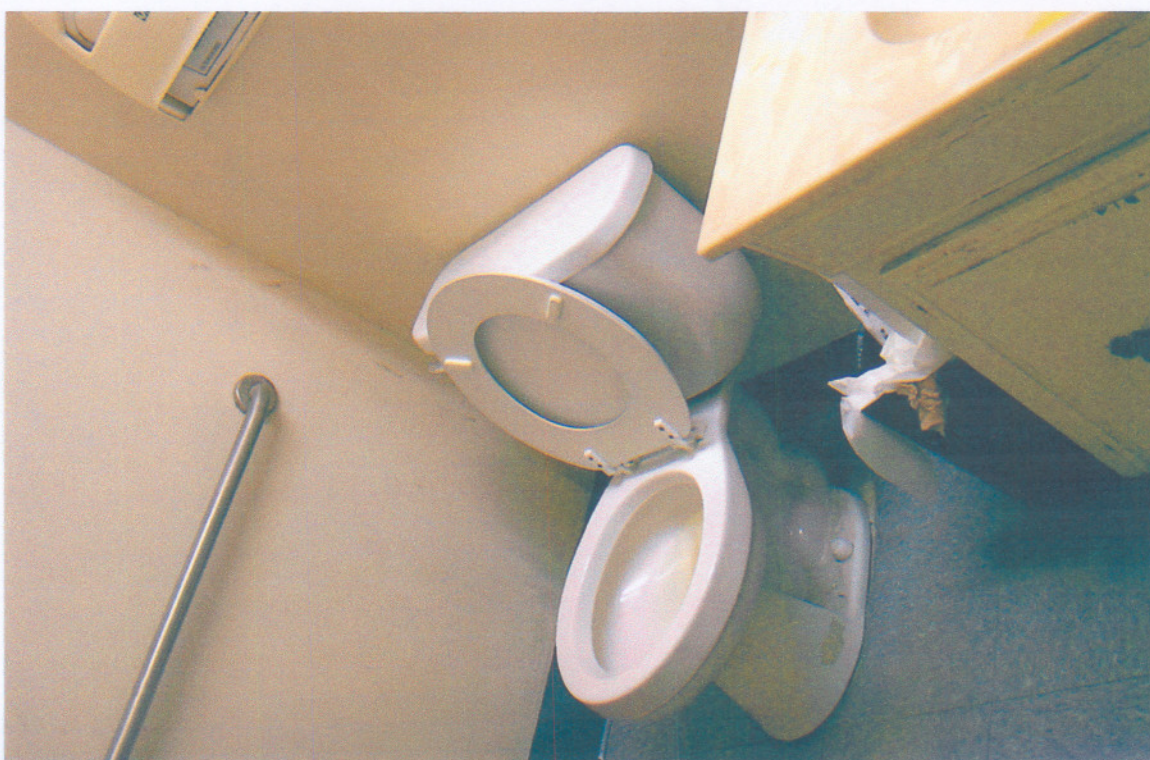
EXHIBIT "2"  
2

1 visit. As can be seen in Exhibit "2", there was no rear grab  
2 bar. The side grab bar was not located 33 inches on center from  
3 the finished floor. The toilet flushing mechanism was not on the  
4 open side of the toilet. The top of the toilet seat was only  
5 about 15 inches from the finished floor. The lavatory had no  
6 knee clearance. The lavatory faucet handles required tight  
7 grasping or twisting to operate. The bottom edge of the mirror  
8 was more than 40 inches from the finished floor. The toilet seat  
9 cover dispenser was located behind the toilet and more than 40  
10 inches from the finished floor. There was no signage on the door  
11 indicating the accessibility of the restroom.

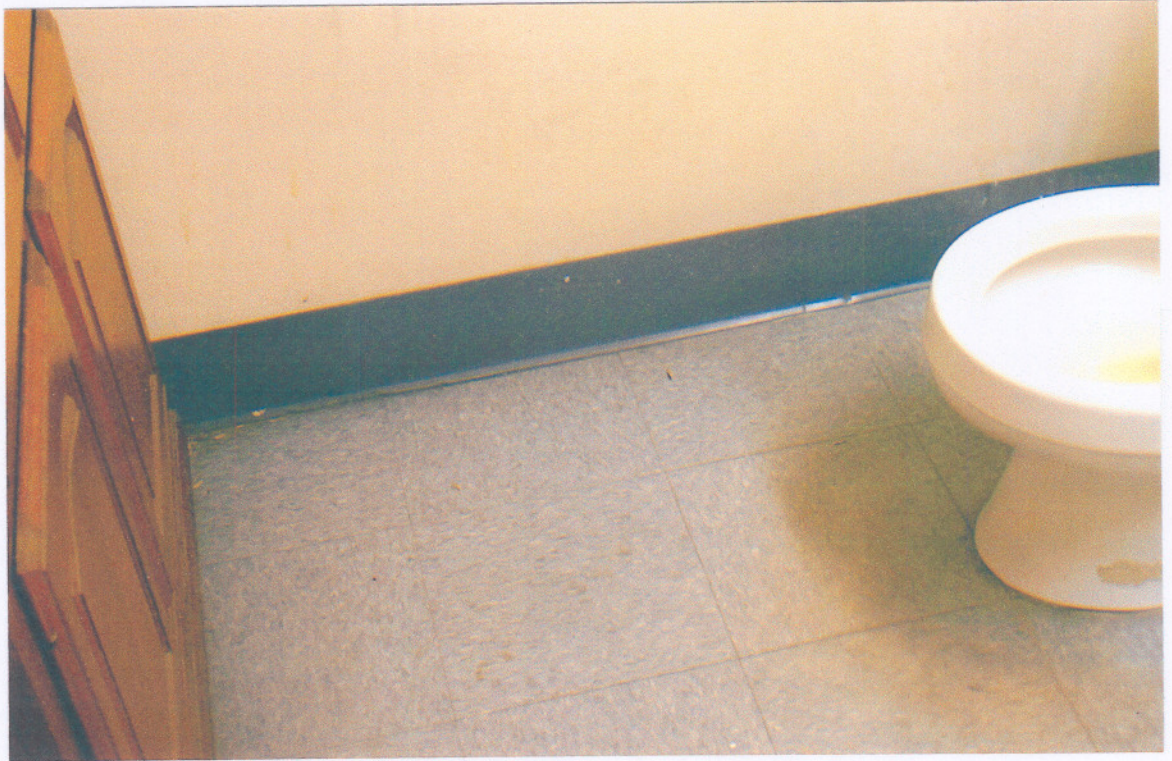
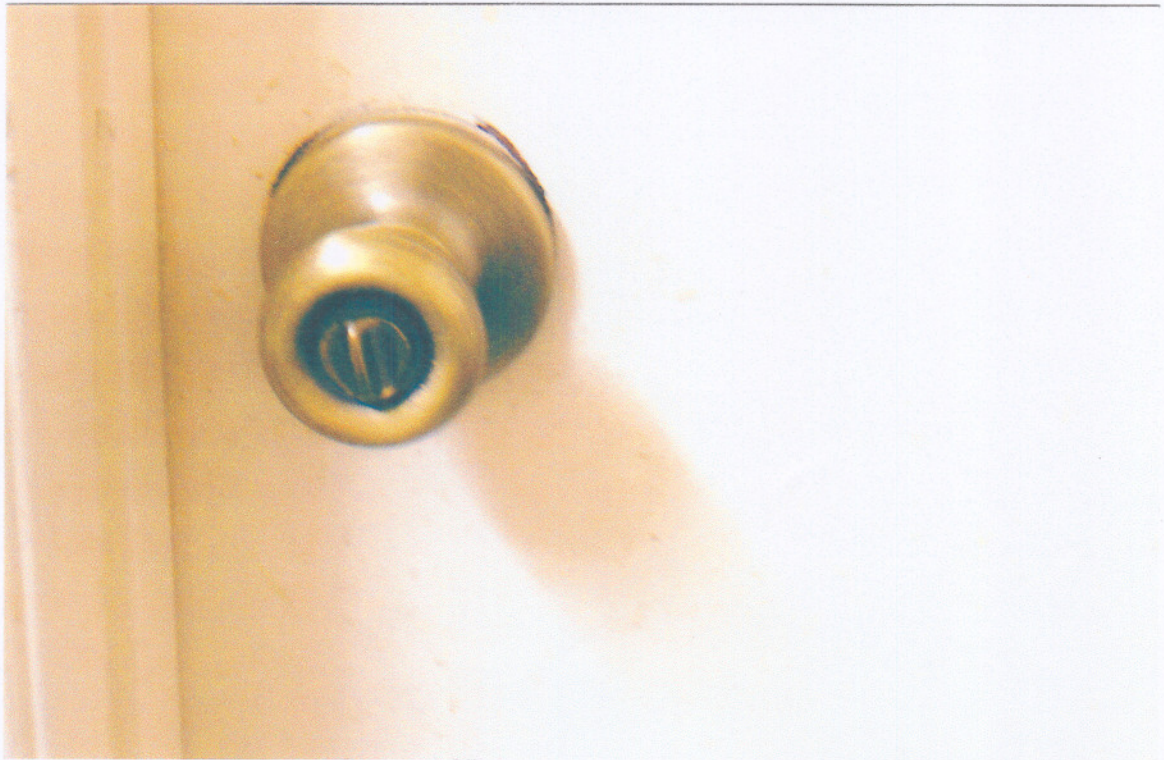
EXHIBIT "3"  
3

12 7. Exhibit "3" shows that, during my visit, the restroom  
13 doorknob was round and required tight grasping and twisting to  
14 operate, as did the locking mechanism for the door. The distance  
15 from the side of the toilet to the far wall was only about 10  
16 inches because of the location of the lavatory. The distance  
17 from the front edge of the toilet to the front wall was only 32  
18 inches.
